TECHNICAL BULLETIN

MODEL/DERIVATIVE:
MGF

Bull. No: 0016
CDS. ref: M6932bu
Issue: 2
Date: 10/12/97

HARDTOP POOR FIT TO DOOR GLASS OR REAR DECK - VARIOUS

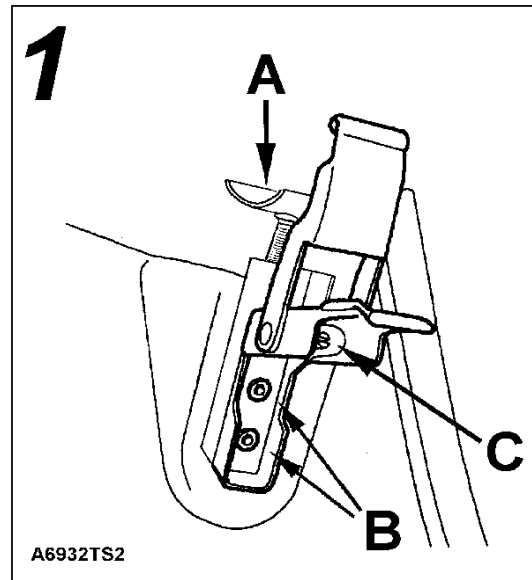
The new modified catch has an integral height stop shoe *illustration 1 (A)*, which controls the hardtop height. When adjusted correctly, the height shoe registers on top of the existing body fixing hook. The catch is then clamped to the hook lower as with original catch. As a result the hardtop will compress the rear seal a predetermined amount. This eliminates excessive seal compression which can result in hardtop fouling tonneau deck.

1. To remove catch first drill out securing rivets (*B*) with a 5mm drill.

2. Remove loose rivet heads by tilting and shaking hardtop until they can be retrieved from the gaps in the lower B-Post. Ensure all four are removed to prevent complaints of rattles.
3. Fit modified catches with special securing rivets, part number DYQ 100340. Ensure the rivet gun used has a nose narrow enough to enter the catch carrier. Failure to ensure this will result in incorrect register of the rivet head.

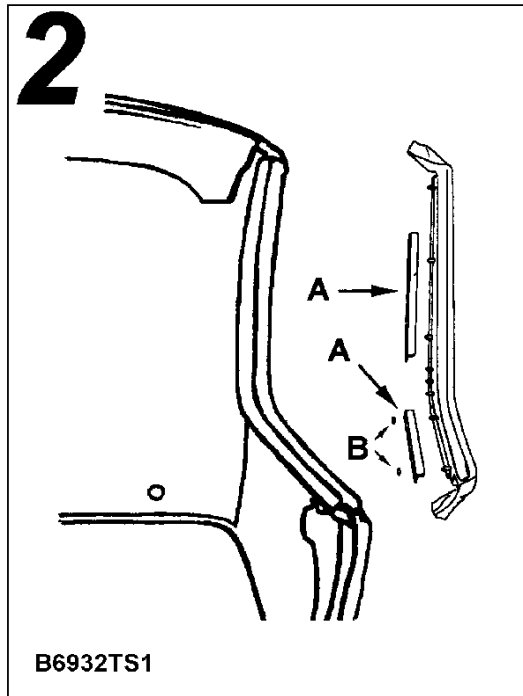
These newly introduced 'soft solid' type seals are fitted with special support brackets to improve seal profile and enhance glass to seal fit.

1. Remove and discard old seals along with fixings. Clean any remaining adhesive from the base of each B-Post and the front corners of hardtop where previous seals were attached.
2. Pre-assemble the new cantrail seals by pressing the brackets *illustration 2 (A)* onto the seal fir tree fixings by hand in the positions shown.
3. Press on additional fibre washers (*B*) to each B-Post bracket fixings (shorter bracket of two).
4. Fit seal assemblies to hardtop by pressing fixings into their original locations, start at the 3rd fixing up from the B-Post. Referring to *illustration 3*, ensure that brackets (*A*) all register against the inner panel (*B*), this will then provide the correct profile between seal (*C*) and hardtop roof (*D*). Ensure also that cantrail seal run is free from indentations.

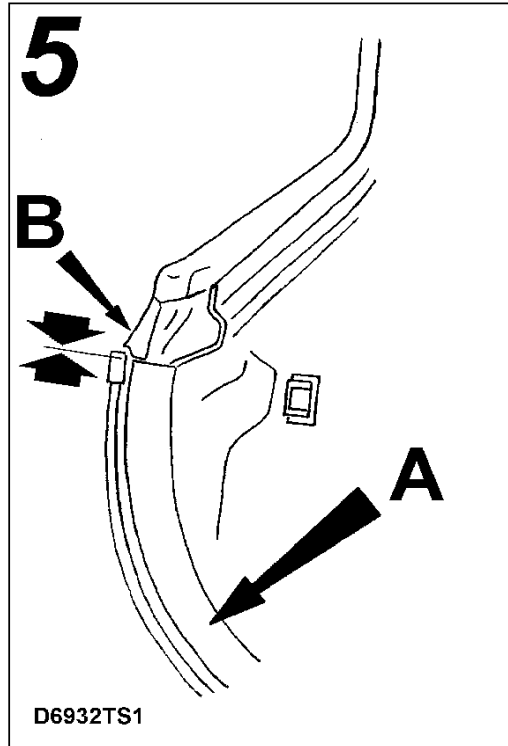
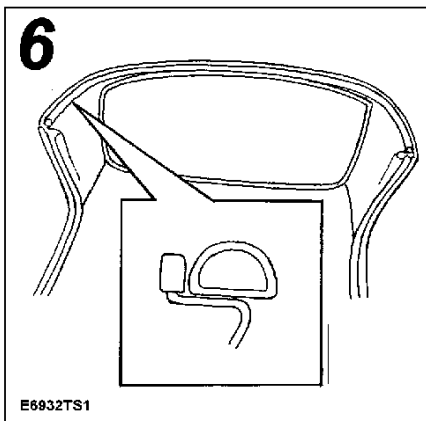
The later 'D' section seal is a service part only and must only be fitted to vehicles up to hardtop serial number F493. This seal will provide sufficient clearance between hardtop and tonneau deck to prevent direct contact.

5. Apply the seal *illustration 5 (A)* to the hardtop. Begin at one side by butting up seal end to the flip tail of the cantrail seal *(B)*. While ensuring that continuous contact is made between the flat section of seal and its mating face of the hardtop *illustration 6 (inset)*, continue to apply until it over laps the cantrail seal on the opposite side. Using a sharp knife, trim off surplus seal so that a good 'butt' joint is obtained. Apply firm pressure to seal to ensure a good bond is made.
