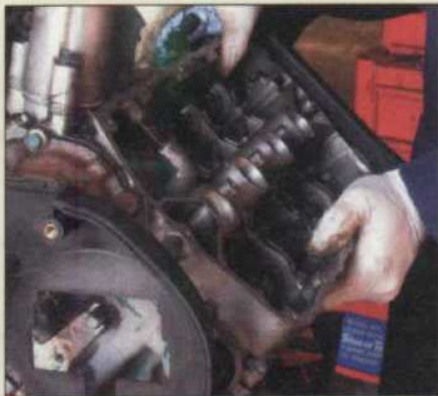
**7** Remove the 8mm bolt from the top rear half of the timing belt cover. This will enable the cylinder head to be removed. Crack from the inside out, the ten Torx E12 head bolts. Store in sequence if you want to re-use them (see Rebuild Tips) and remove the head.

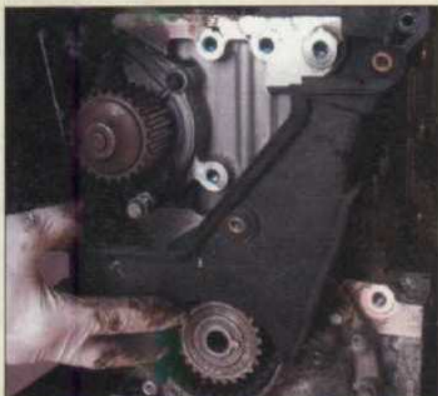
**9** Remove the front crankshaft pulley bolt and pulley. Then remove the bottom timing belt cover, fitted with three 8mm bolts. Remove and discard the timing belt.

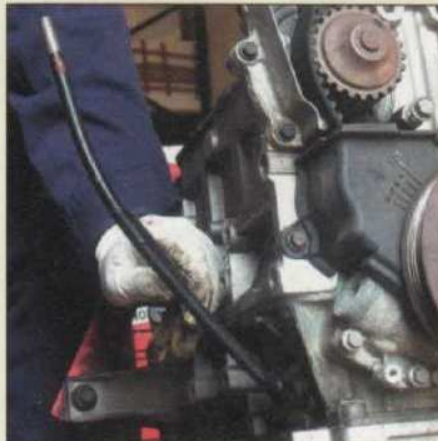
**8** Remove the engine oil dipstick tube. This is fitted with two 8mm bolts at the base and one 13mm bolt for the steady bar bracket. Renew the gasket fitted – this has been known to leak oil.

**Oil leaks** – typical leaks include the camshaft oil seals and around the VVC housing. The base of the engine oil dipstick tube can also leak, usually cured with a new gasket or by re-tightening the bolts (see Step 8).

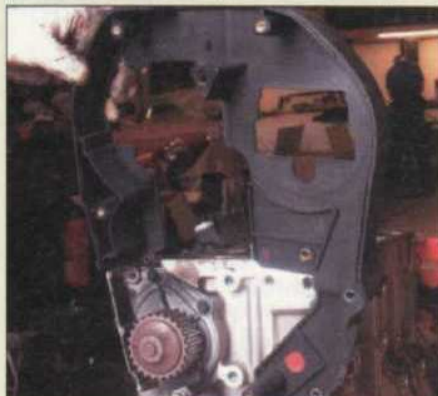
**10** Remove the rear top timing belt cover, fitted with two remaining 8mm bolts – one at the front and one at the rear that goes into the water pump housing.

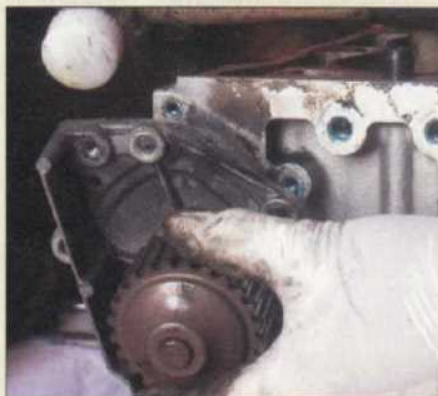
**11** Undo four 8mm bolts for the water pump and one 13mm bolt which includes a locator for the timing cover. The water pump may need a gentle tap with a plastic hammer to break its seal to the engine block.

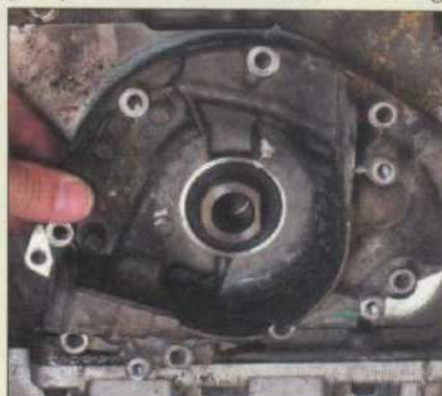
**12** Remove the oil pump, fitted with nine 8mm bolts. All bolts are of equal length, except for the one fitted at the top left. Renew the gasket and rubber o-ring oil seal. To dismantle pump if required, undo two Torx screws underneath the gasket.
